## Dolphin Tower Emergency Structural Repairs and Rehab

<b>Location:</b>	Sarasota, FL
<b>Submitted by:</b>	Concrete Protection & Restoration, Inc.
<b>Owner:</b>	Dolphin Towers Condo Association
<b>Engineer:</b>	Morabito Consultants
<b>Contractor:</b>	Concrete Protection & Restoration, Inc.
<b>PT Supplier:</b>	PTE Systems International, LLC
<b>Other Contributors:</b>	Karins Engineering Group, CEMEX

# Dolphin Tower Condominiums Emergency Structural Repair

Sarasota, FL

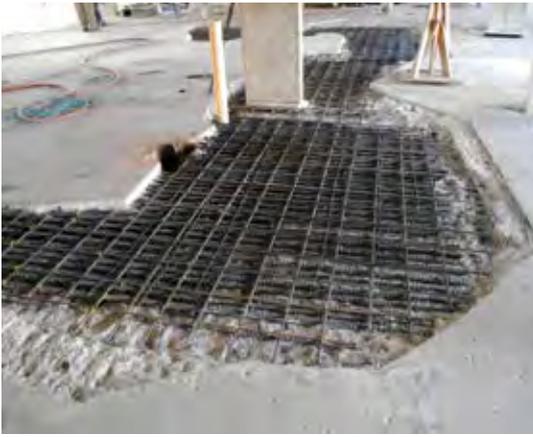
The first phase of the repair was to fix the large shear failure crack within the fourth-level transfer slab, which spanned four column bays. The repair

*Fourth-level transfer slab crack repair after demolition*

comprised conventional selective demolition and replacement along with epoxy injection. This would further weaken the already damaged transfer slab, so additional shoring was installed. Additional steel was added to the repair areas where concrete was removed, and the floor was re-placed to its original level.

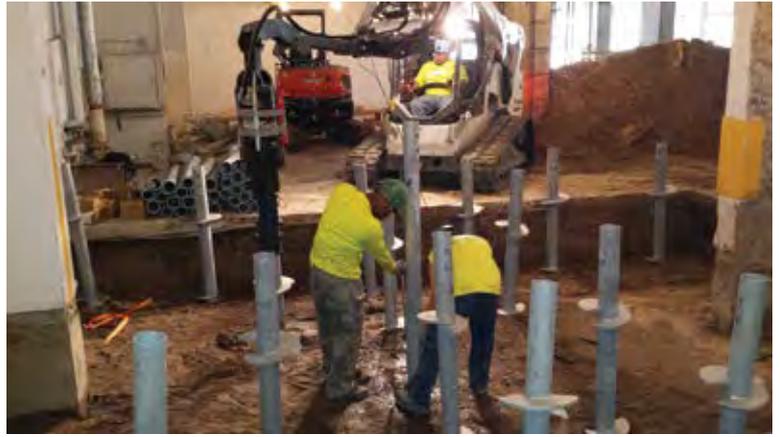
*Helical pile installation in the foundation area*

Simultaneously, work began on Phase 1 of the foundation strengthening, which consisted of areas that fell outside of the existing shoring and could easily be accessed. The foundation work consisted of demolishing and removing the slab-on-ground concrete, excavating down to the existing concrete pile caps, installing new steel helical piles, placing steel reinforcement, and placing of the new expanded pile caps.

During excavation of the first pile cap location, it was discovered that the existing cap was only 16 in. (406 mm) deep. However, the original construction as-built drawings showed a pile cap depth of 29 in. (737 mm). The same was true for 10 out of 12 of the Phase 1 pile caps. Based on these existing conditions, the structural engineers had to revise their original designs.

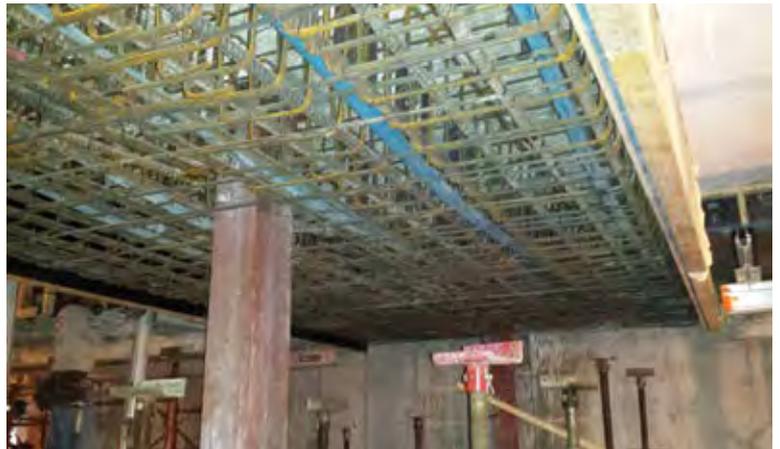
*Post-tensioned drop panels with formwork*

The second phase of the project was to install the post-tensioned drop panels on the underside of the fourth-floor slab. The ceiling was prepped using hydrodemolition, and then column enlargements were installed on Level 3. Six-hundred 8 in. (203 mm) holes were cored through the fourth-level slab to install “shear lug keys.” These would tie the new drop panel to the fourth-level overlay, creating a new composite slab.

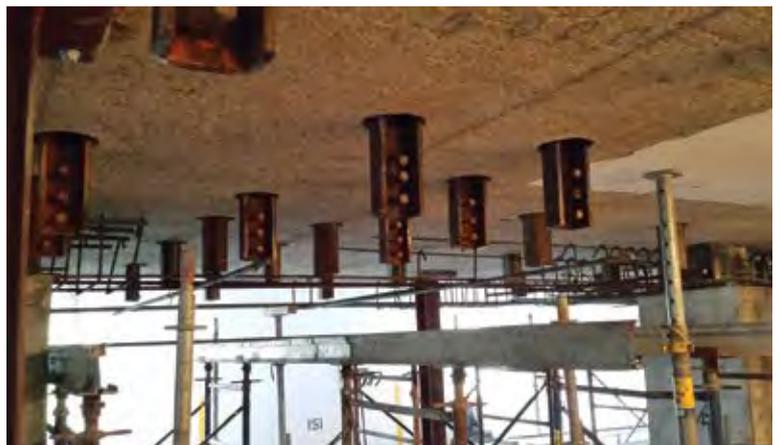
*Steel lug keys and reinforcing bars in the drop panels*

panels were hung from the lug keys, and the post-tensioning cables were installed within the cage. Post shores were installed underneath the drop panel formwork and across 100% of the tower area on all three levels of the garage. This shoring would support the new construction of the drop panels and overlay. In total, 2800 post shores and 200 shoring towers were used for the drop panel and overlay construction.

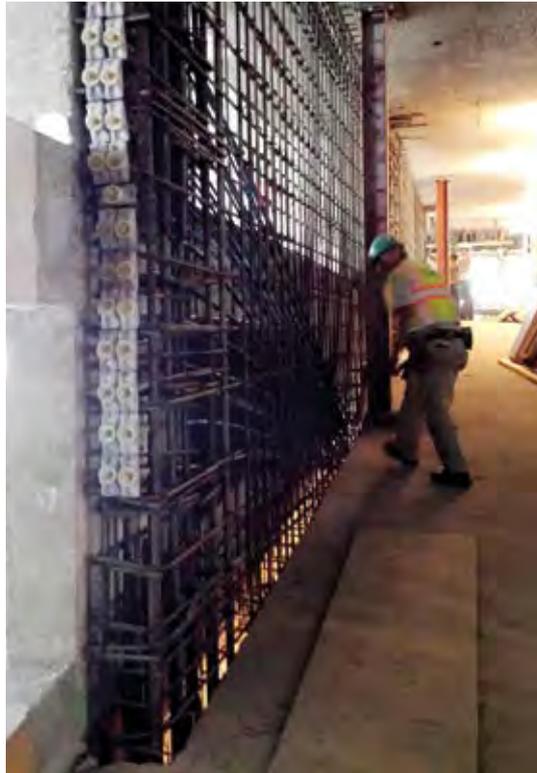
*Steel and cables in the post-tensioned beam*

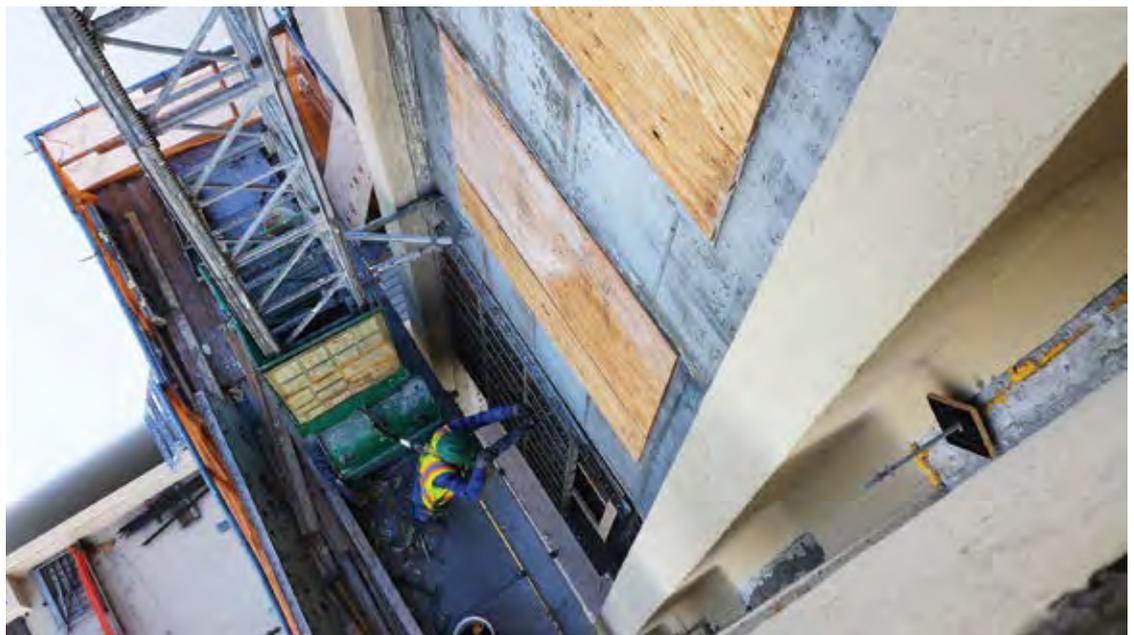
*Exterior shear walls*

Also during the second phase, exterior wall segments at the four corners of the building were

converted to concrete shear walls. The existing windows and concrete masonry unit (CMU) walls were removed, reinforcing steel was installed, and concrete was placed.
